CALSPAN ON-SITE AIR BAG DEPLOYMENT INVESTIGATION

CALSPAN CASE NO. 92-10

VEHICLE - 1991 DODGE CARAVAN

ACCIDENT DATE - [REDACTED] 1992

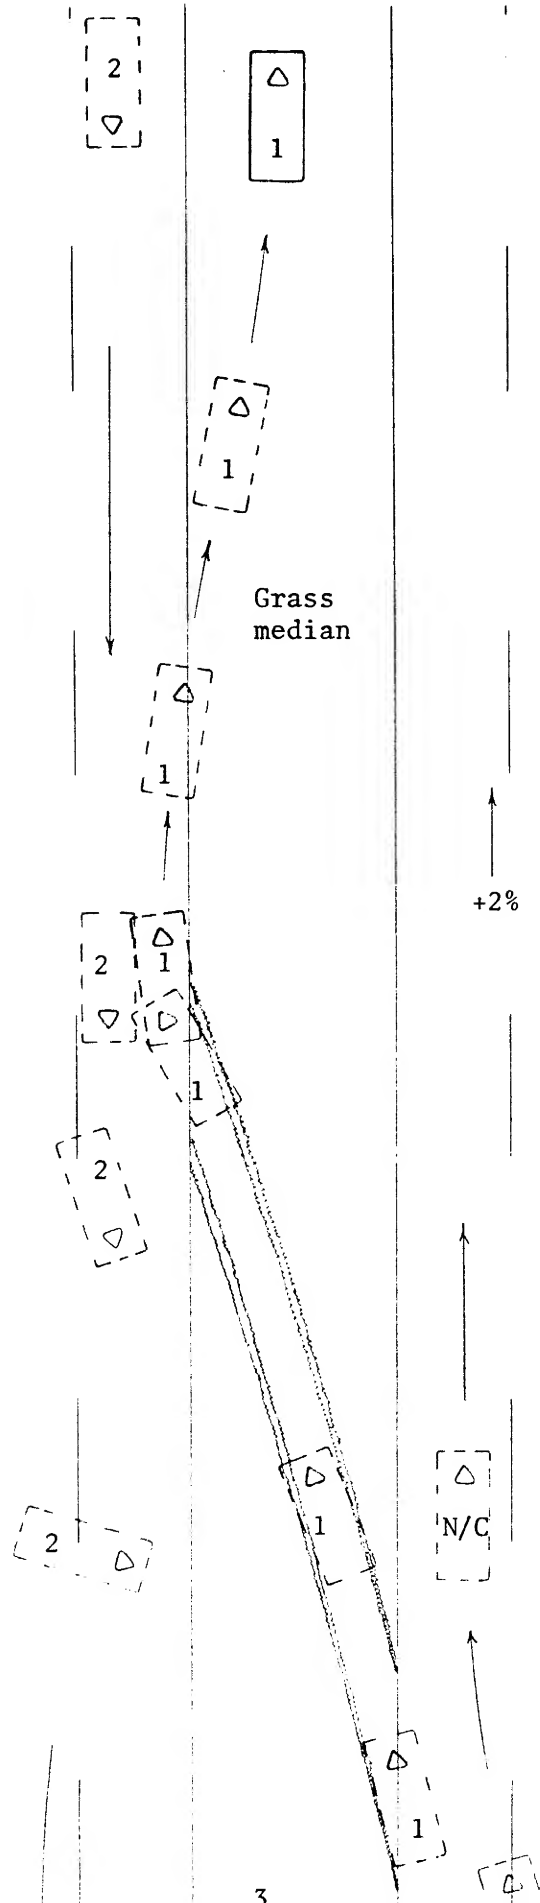
#1 - 1991 Dodge
Caravan

#2 - 1988 Dodge
Caravan SE

Paved
shoulder

Approximate
Final Rest
Position of
V-2

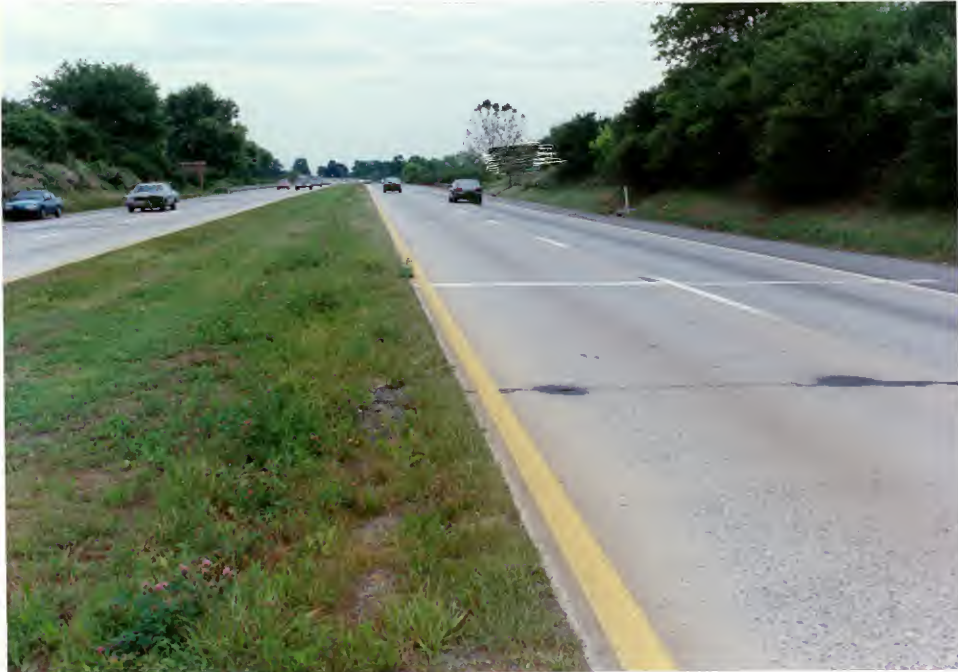
Pre-Crash Trajectory Of The 1991 Dodge Caravan.

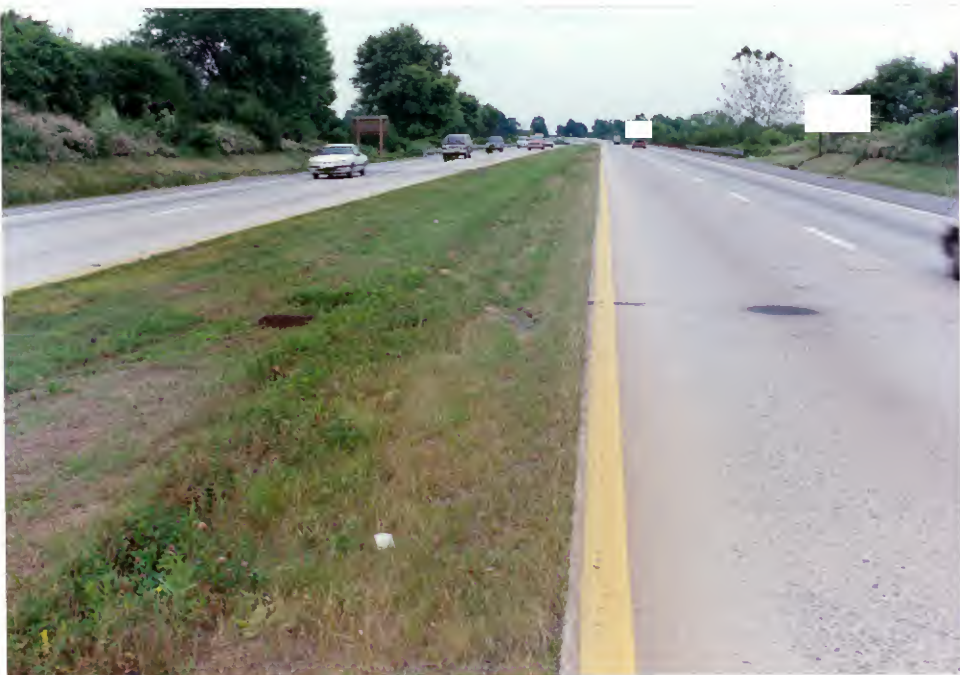
Vehicle Departs Roadway And Enters The Grass Median.

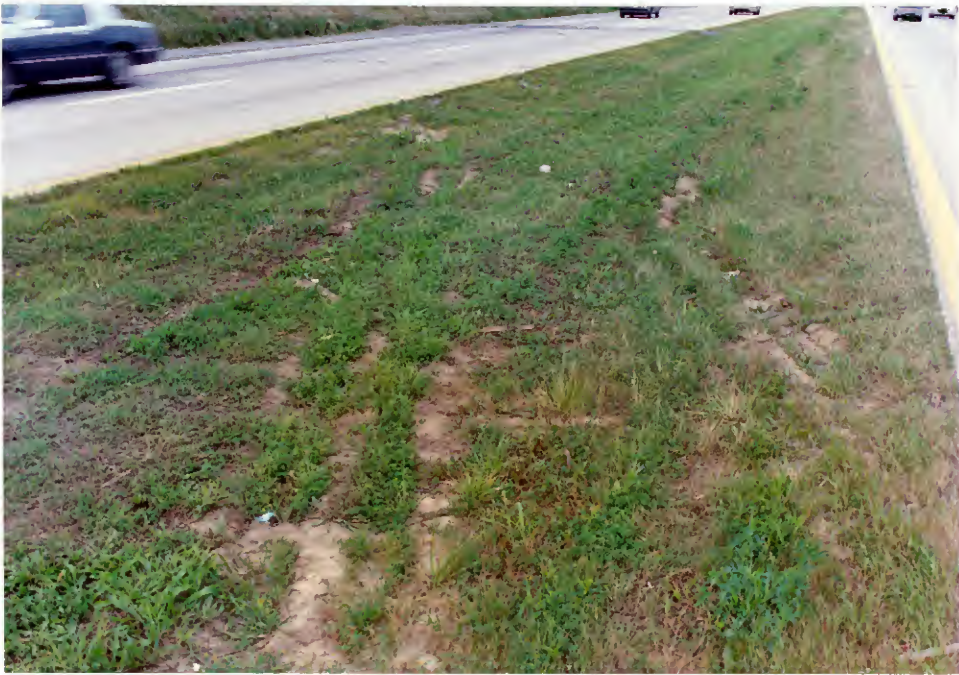
Vehicle's Trajectory Across The Grass Median.

Based on physical evidence found at the crash scene, the Dodge Caravan initiated a slight counterclockwise yaw of approximately 8° as it traversed the grass median.

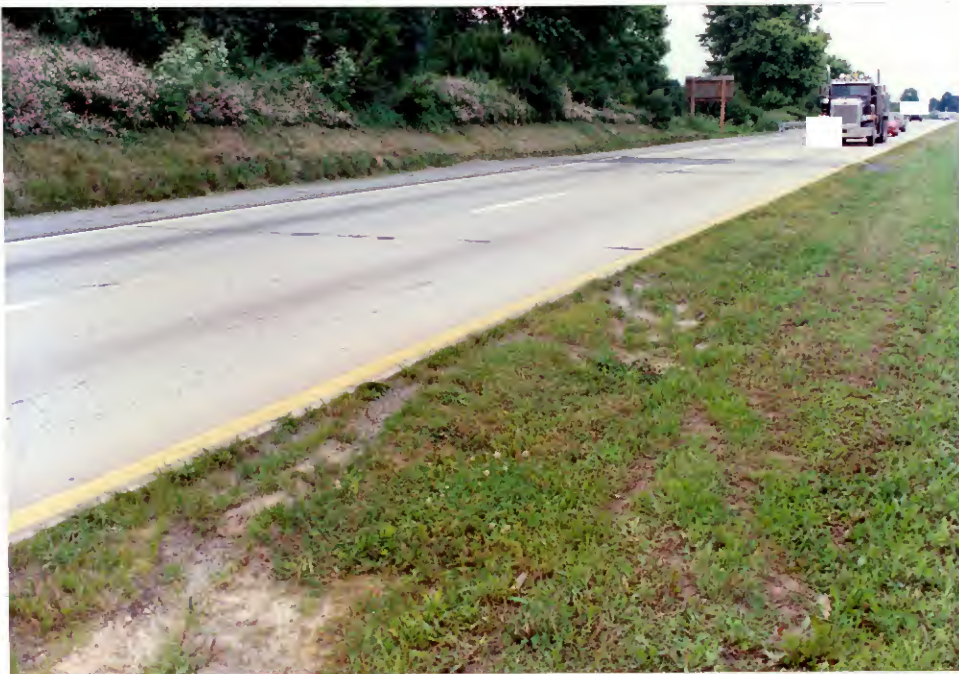
1991 Dodge Caravan Enters The Westbound Traffic Lane
And Impacts The 1988 Dodge Caravan.

Crash: The left frontal area of the 1991 Dodge Caravan impacted the left side area of vehicle #2. Initial contact on vehicle #2 began at the left front wheel and extended rearward as the vehicles continued in their respective directions. The left front bumper area of the air bag equipped Dodge Caravan engaged against the left front door, quarter panel, and the left rear tire and wheel assembly of vehicle #2. The impact fractured the axle assembly which resulted in complete separation of the tire and wheel. Resultant directions of force were within the 1 o'clock sector for the 1991 Dodge Caravan and 10 o'clock for vehicle #2.

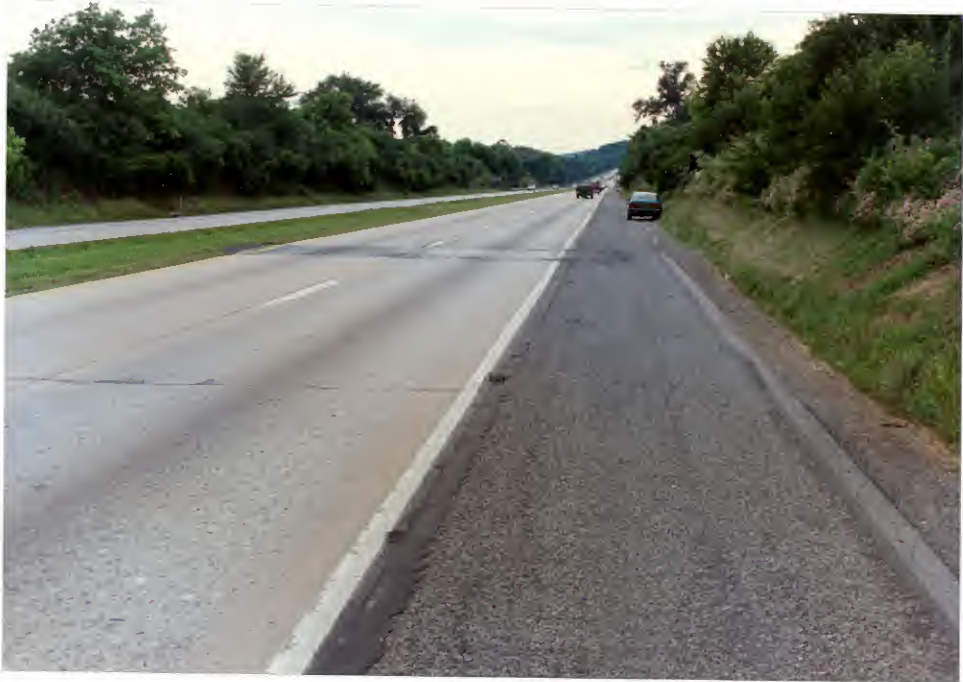
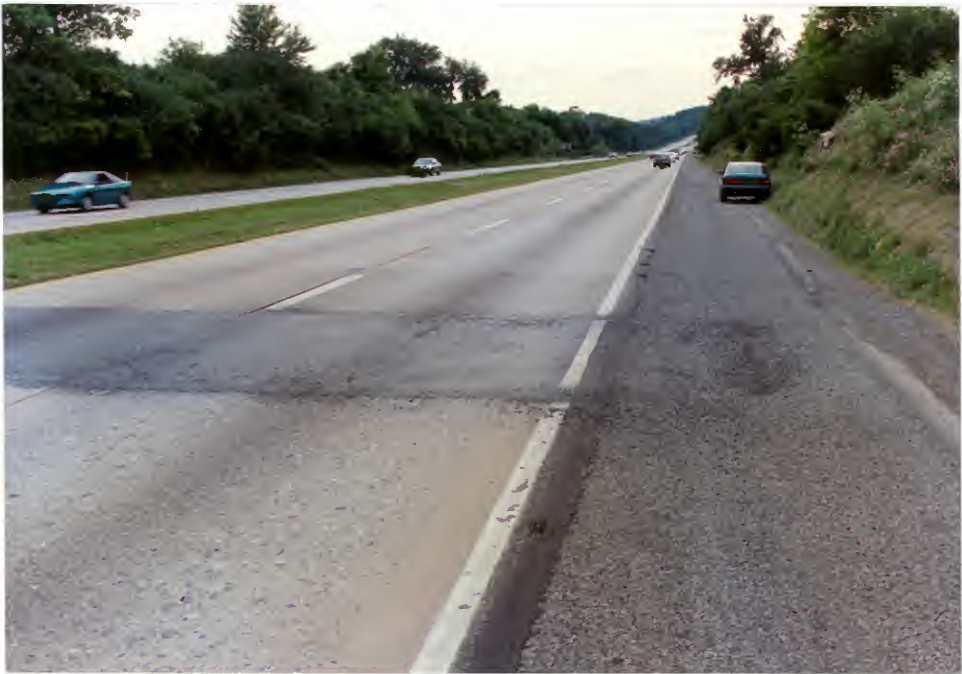
Trajectory Of The 1988 Dodge Caravan.

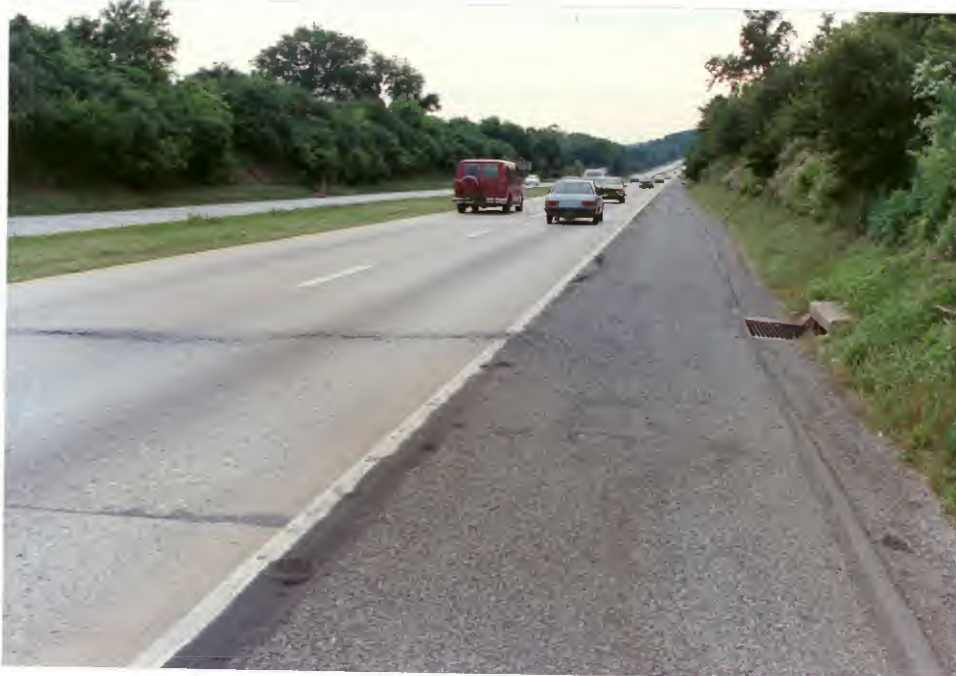
Final Rest Area Of The 1988 Dodge Caravan.

Final Rest -	The driver of the 1991 Dodge Caravan relinquished control of the vehicle at impact. The Caravan was deflected in a clockwise direction onto the grass median where it came to rest facing in an easterly direction. Vehicle #2 overturned on the concrete road surface and came to rest on its roof. At final rest, vehicle #2 was blocking the outboard westbound travel lane and was facing in a northwesterly direction, diagonal to the roadway.
Driver Activities -	<p>The driver of the air bag equipped Dodge Caravan noted a smoke-like substance (air bag discharge) within her vehicle as it came to rest. She initially thought that the vehicle was on fire. The driver immediately unfastened her active restraint system and opened the left front door and exited the vehicle. She waited on the grass median for police and rescue personnel to arrive on-scene.</p> <p>The occupants of the overturned vehicle #2 were hanging upside down in the vehicle by the active belt systems. The driver smelled gasoline leaking from her vehicle and she began to panic. She stated that she had difficulty releasing the buckle assembly of her belt system due to her emotional state and not because of hardware malfunction. As the driver unbuckled her belt system, she crawled out of the vehicle through the left front door window opening. Her right front passenger unbuckled her restraint system without difficulty and exited the vehicle through the same opening.</p>

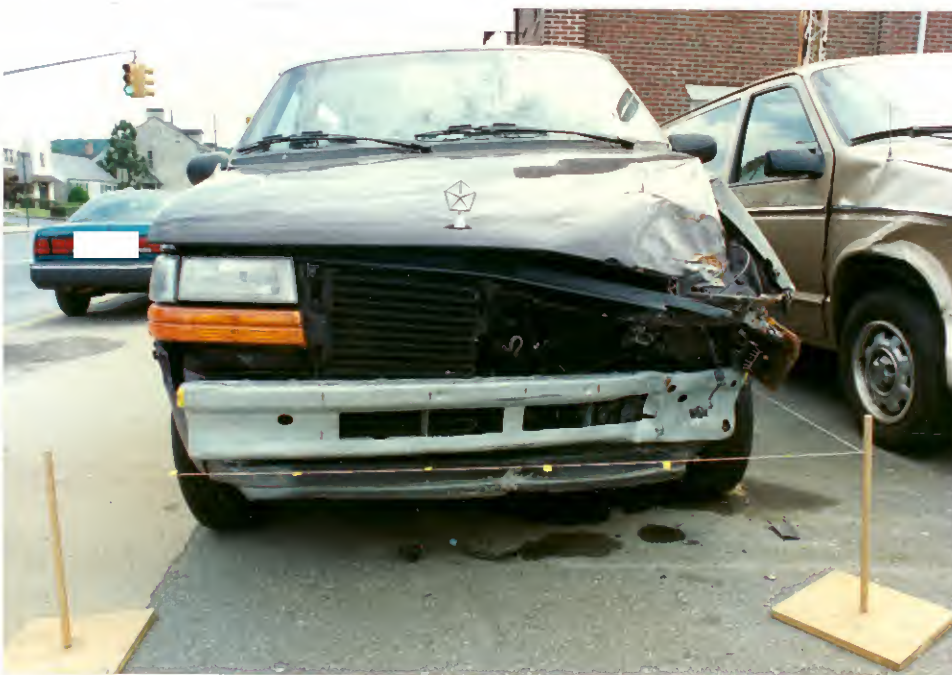
Frontal View Of The 1991 Dodge Caravan.

<u>Air Bag Vehicle</u>	<u>Vehicle #2</u>
Exterior:	<p>The air bag equipped 1991 Dodge Caravan sustained moderately severe frontal crush from its impact sequence with the side of vehicle #2. Maximum crush was 41.6cm (16.375") located at the left corner of the front bumper reinforcement bar. Direct contact damage on the bumper fascia began 28.6cm (11.25") left of center and extended 48.9cm (19.25") to the corner. The bumper fascia subsequently separated from the reinforcement bar and contacted the concrete road surface which resulted in abrasions across the full width of the fascia. The impact deformed the entire frontal area of the vehicle which resulted in a combined induced and direct contact damage of 139.7cm (55.0"). Crush values at the bumper reinforcement bar were as follows: C₁=41.6cm (16.375"), C₂=32.1cm (12.625"), C₃=20.0cm (7.875"), C₄=9.8cm (3.875"), C₅=2.2cm (0.875"), C₆=-5.1cm (-2.0").</p> <p>As a result of the front to side impact configuration, the 1991 Dodge Caravan sustained a 1 o'clock impact force. The</p>	<p>The 1988 Dodge Caravan sustained moderately severe left side damage from its impact sequence with the air bag equipped minivan. Direct contact damage began on the left front wheel, 15.2cm (6") rearward of the axle position, and extended rearward 330.5cm (130.1") across the dogleg of the left front fender, left door, and the left quarter panel. The direct contact damage ended at the left corner of the rear bumper. Maximum crush was 21.9 cm (8.625"). located on the lower crease of the left quarter panel 17.8cm (7") rearward of the left B-pillar. Crush values at the lower body crease level were as follows: C₁=4.4cm (1.75"), C₂=14.6cm (5.75"), C₃=19.1cm (7.5"), C₄=20.0cm (7.875"), C₅=14.3cm (5.625"), C₆=0.0cm (0.0"). The left door was jammed closed due to exterior deformation.</p> <p>As the bumper of the air bag equipped Dodge Caravan engaged with the left side of vehicle #2, it contacted the left rear tire and wheel and fractured the axle which resulted in complete separation of the tire, wheel, and brake assembly.</p> <p>The 1988 Dodge Caravan was rotated in a counterclockwise direction by the initial impact and subsequently</p>

Components damaged by the impact included the front bumper fascia, front bumper reinforcement bar, both front frame rails, grille, hood, left headlamp assembly, radiator support panel, radiator, air conditioning condensor, left front fender, left fender support rail, left inner fender, and the transaxle (cracked case). There was no glass damage to the vehicle and all doors remained closed during the crash and fully operational post-crash.

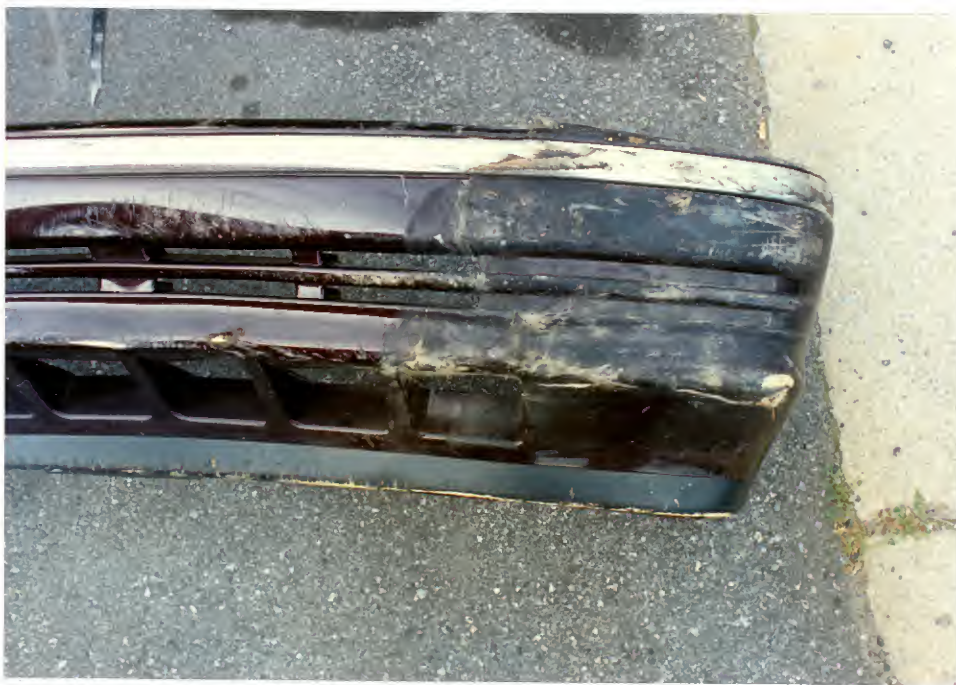
Direct Contact Damage To The Front Bumper Facia.

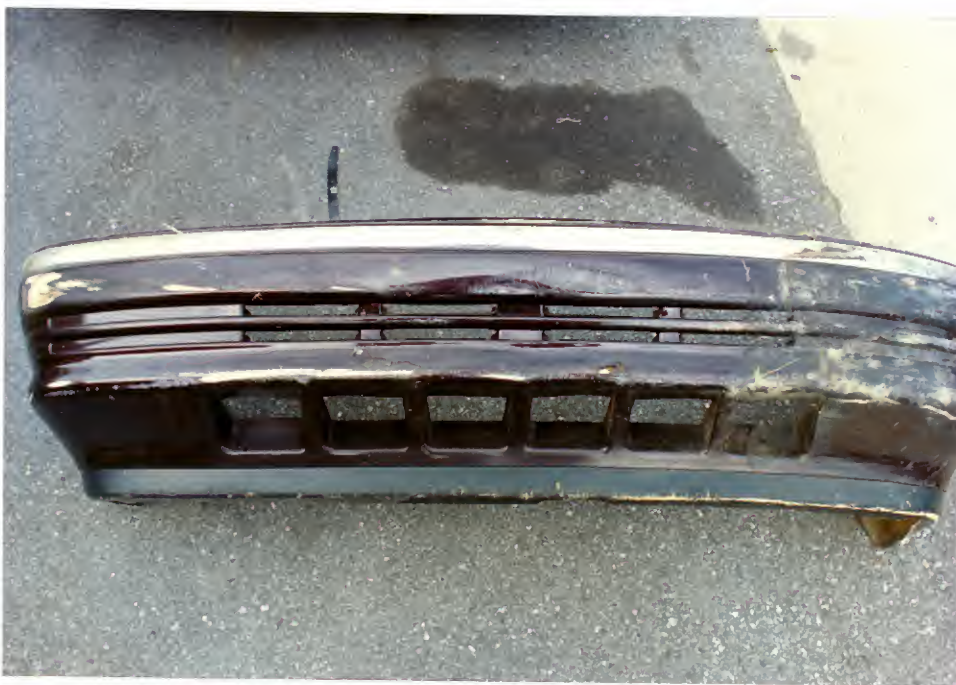
Separated Front Bumper Facia With Road Abrasions Across Entire Width.

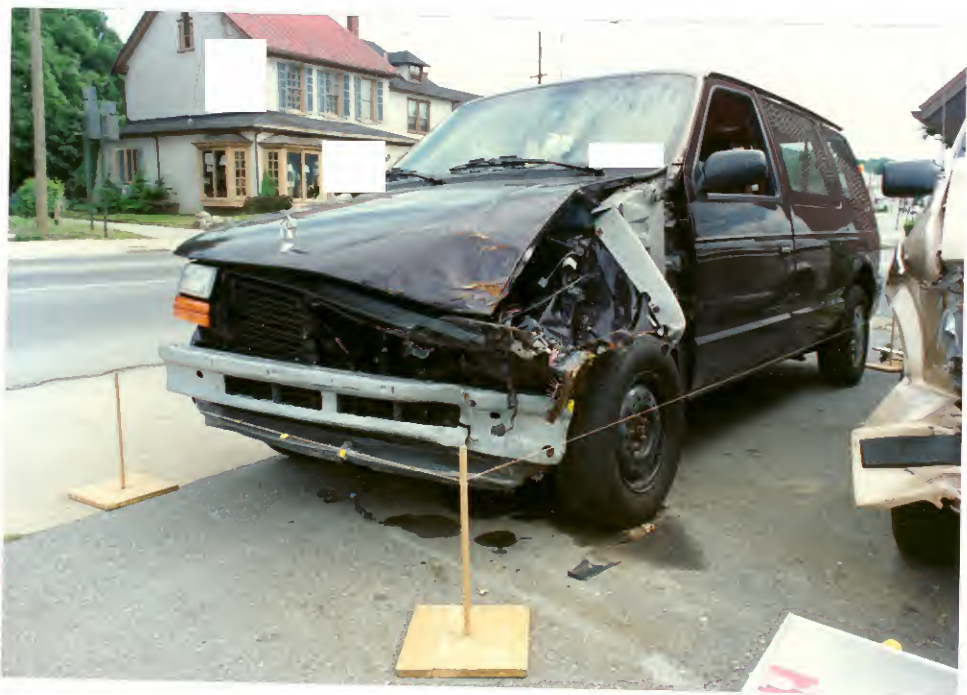
Left Front Three-Quarter View.

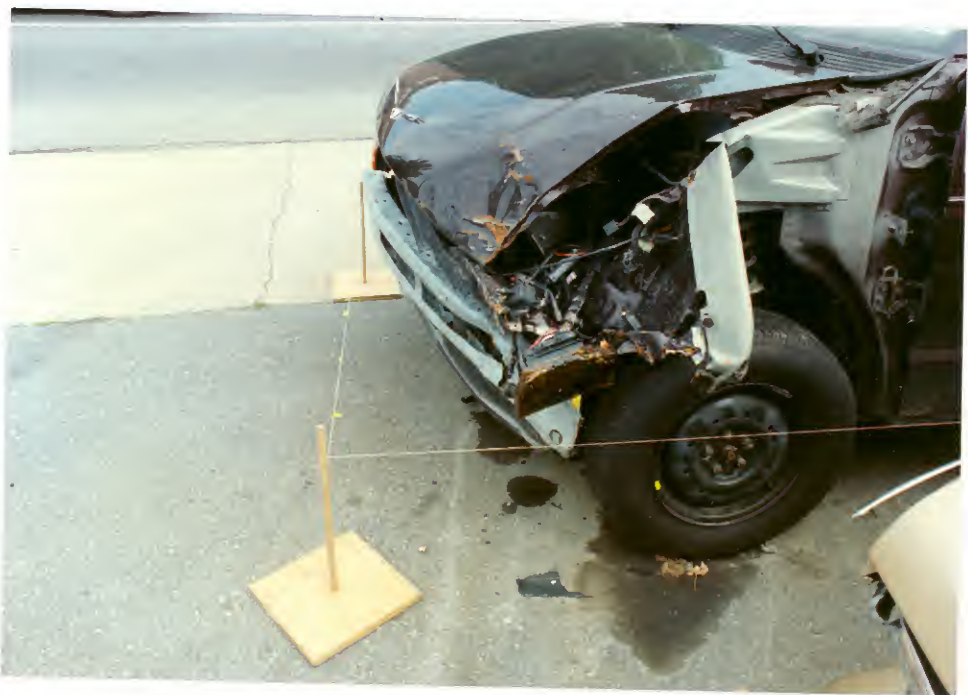
Perpendicular View Showing The Extent Of Crush.

The front left area of the 1991 Dodge Caravan impacted the left side area of the 1988 Caravan. Resultant directions of force were within the 1 o'clock sector for the '91 Caravan and 10 o'clock for the '88 Caravan. Frontal damage to the 1991 Caravan began 28.6 cm (11.25") left of center and extended to the left front corner area of the vehicle. Maximum crush was 41.6 cm (16.375") located at the left corner of the bumper reinforcement bar. Crush values across the front of the vehicle were as follows: $C_1=41.6$ cm (16.375"), $C_2=32.1$ cm (12.625"), $C_3=20.0$ cm (7.875"), $C_4=9.8$ cm (3.875"), $C_6=-5.1$ cm (-2.0").

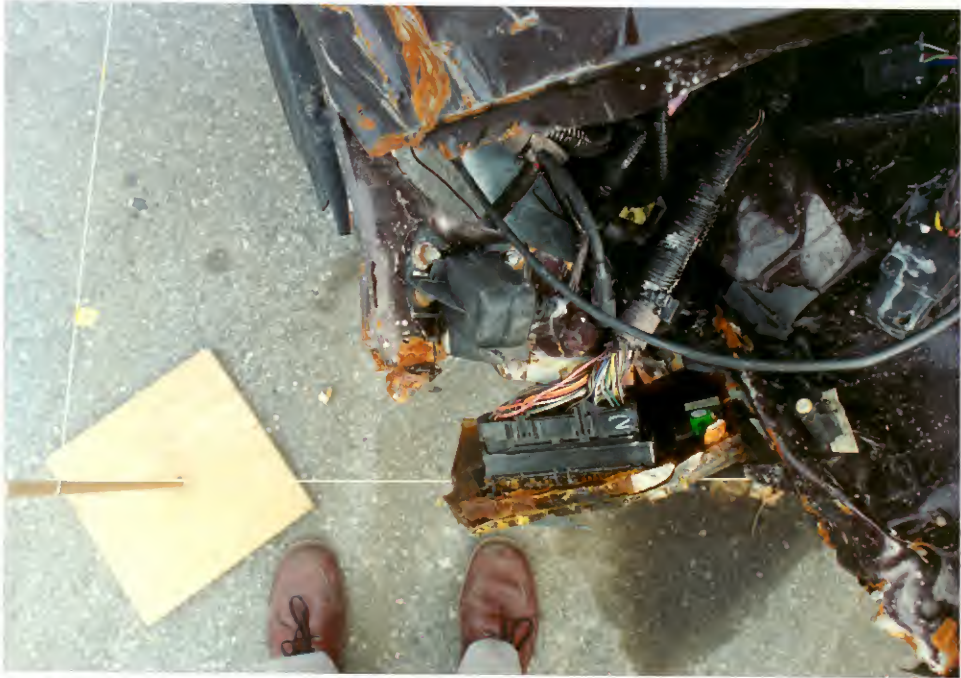
Damaged Left Front Air Bag Crash Sensor.

The 1991 Dodge Caravan was equipped with a supplemental driver's side air bag system which deployed as a result of the vehicle's impact sequence with vehicle #2. The system was equipped with two crash sensors that were mounted to the inner surface of the radiator support panel inboard of the front fenders. The right crash sensor was not damaged; however, the left sensor housing was cracked at the inboard mounting location. The wiring harnesses were not damaged.

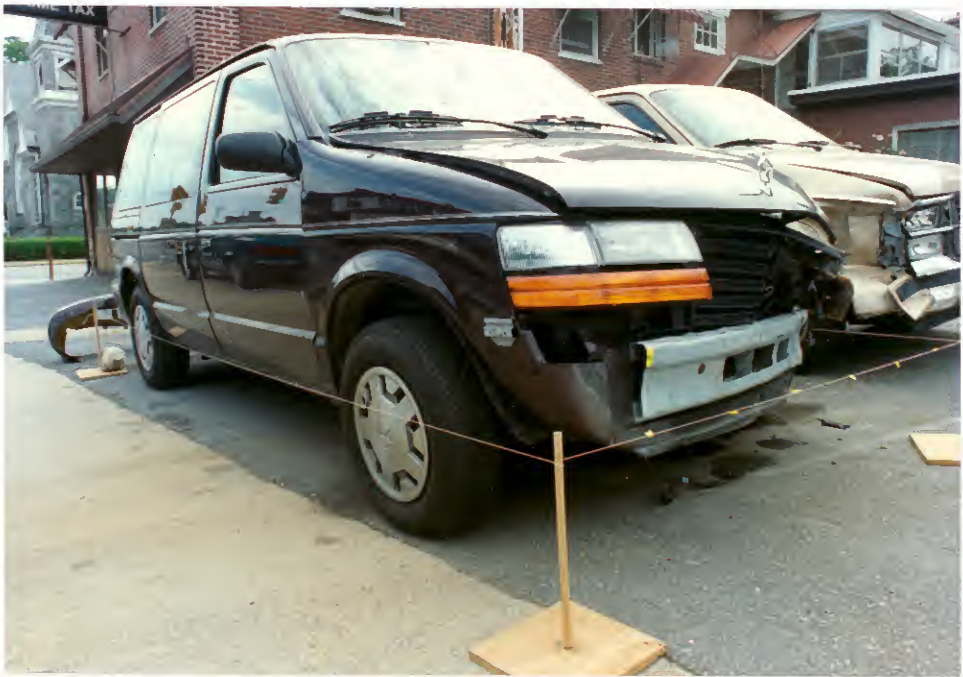
Right Front Three-Quarter View.

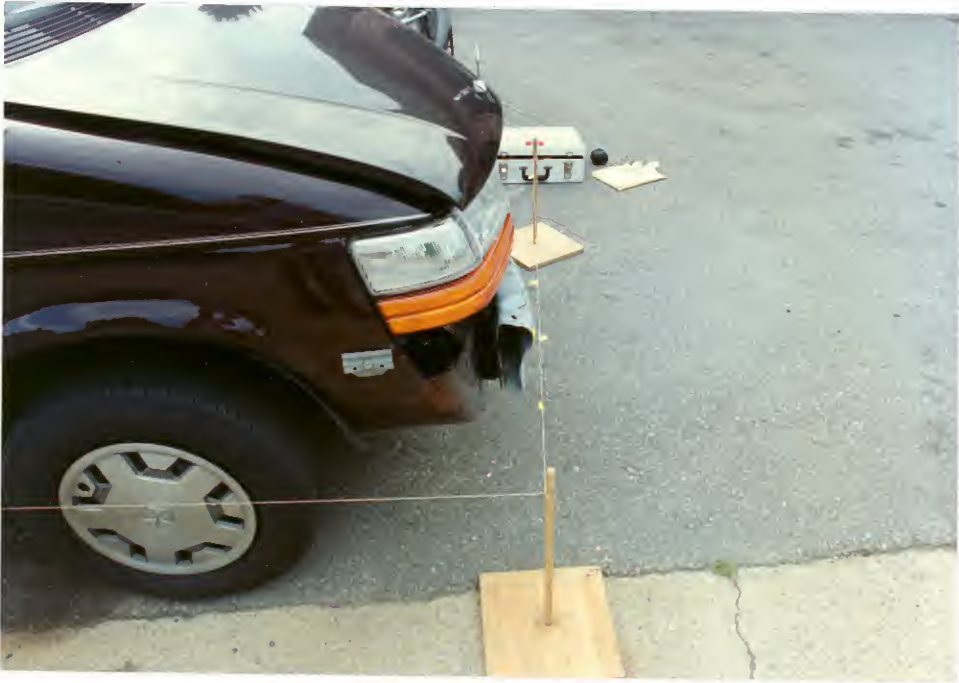
Perpendicular View Of The Right Frontal Area.

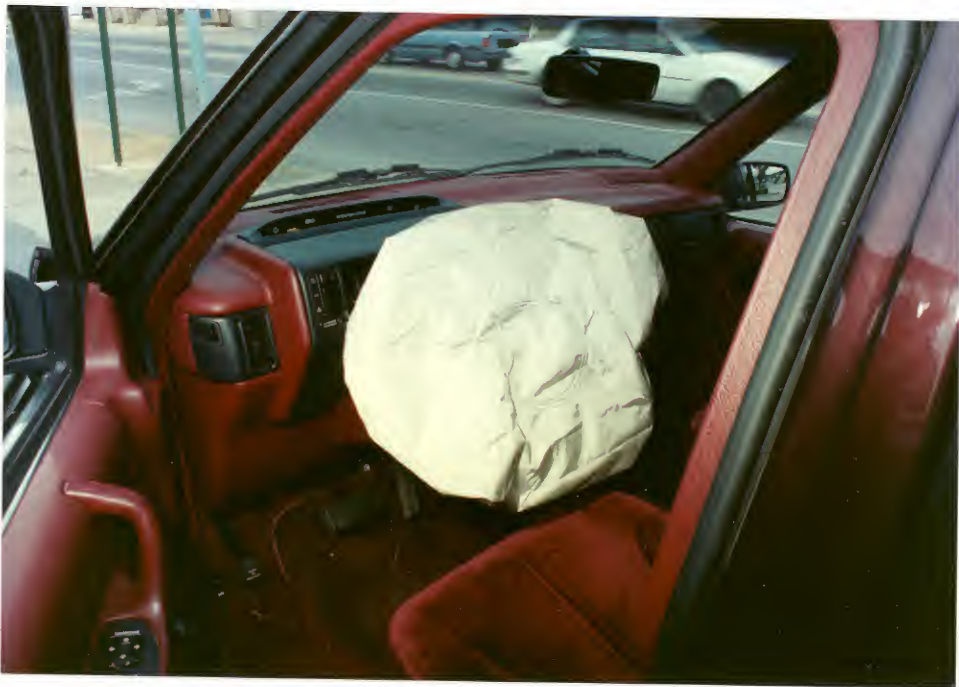
Vehicle's Interior And The Deployed Driver's Air Bag.

Interior: There was no residual damage to the interior of the air bag equipped 1991 Dodge Caravan. The only visible occupant contact point was a possible left knee scuff mark on the protrusion of the knee bolster at the base of the steering column. The contact was located 48.3-52.1cm (19-20.5") left of center and 34.3-35.6cm (13.5-14") below the top surface of the instrument panel. There was no evidence of contact (i.e., makeup transfers) on the deployed air bag or loading evidence on the active belt system.

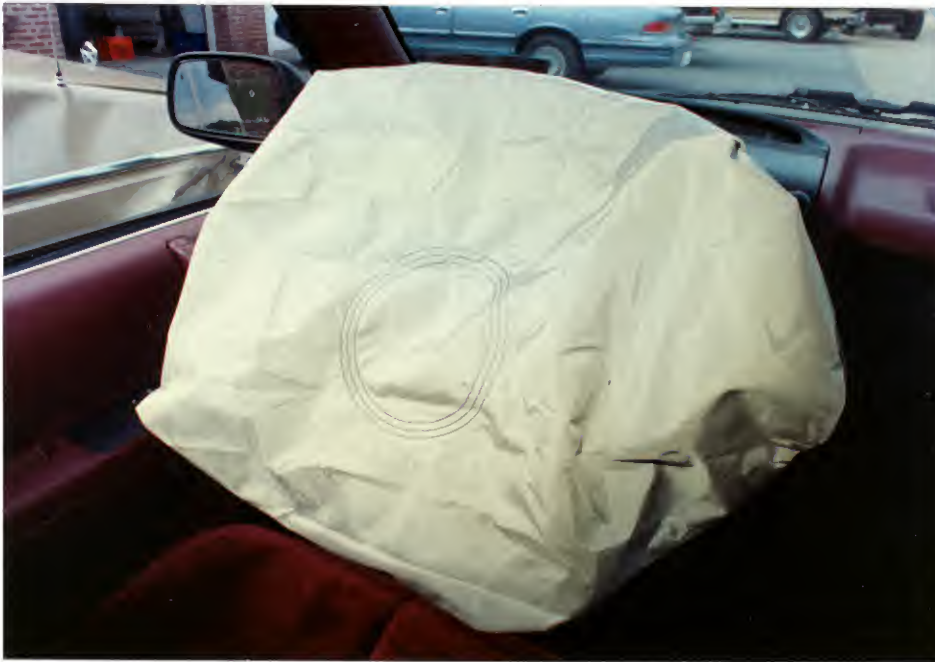
Deployed Driver's Air Bag.

The deployed air bag measured 61 cm (24") in diameter horizontally from seam to seam. The bag was tethered by four internal straps that were sewn to the bag with a 16.2 cm (6.375") diameter tether reinforcement located at the center point of the bag. Three rows of blue stitching attached the tether reinforcement to the face of the bag. There was no damage to the air bag or internal tether straps.

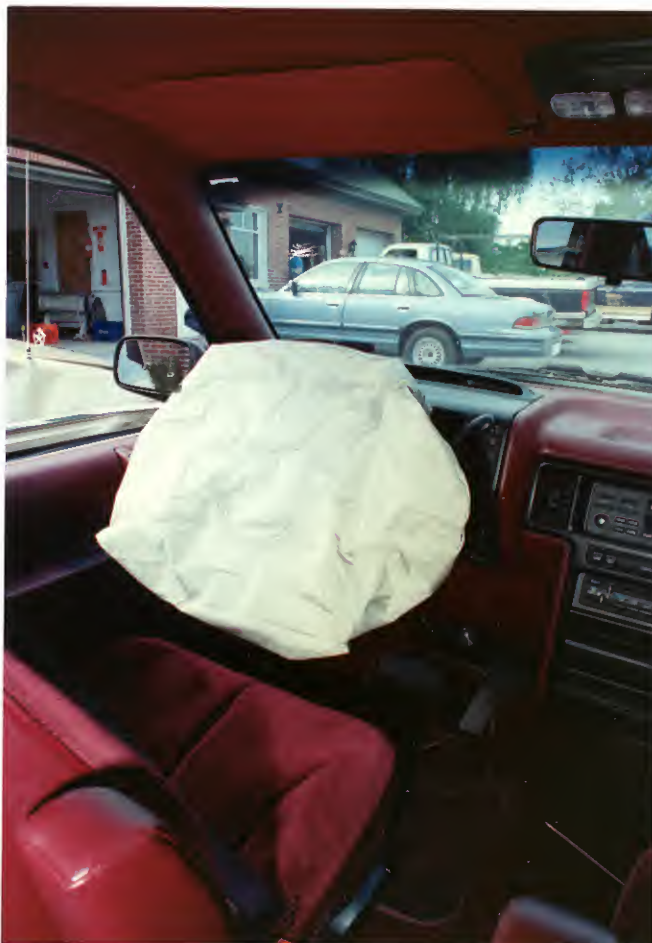
Forward View Of The Driver's Position And The Deployed Air Bag.

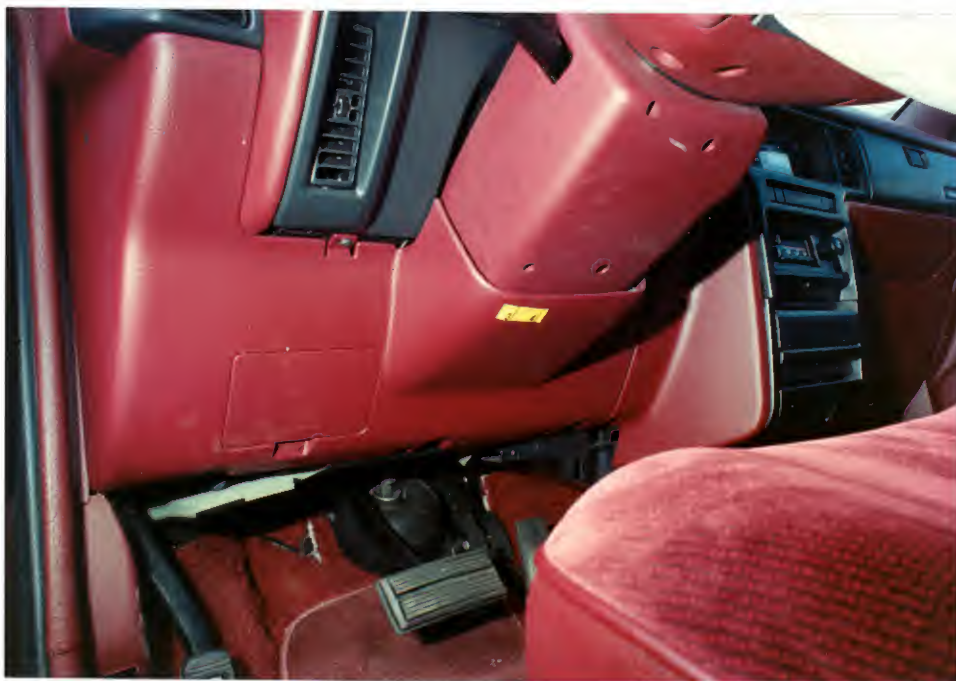
Driver's Left Knee Contact.

The driver's left knee possibly contacted the knee bolster at the base of the steering column. Although no injury occurred, a small diameter scuff mark was noted to the bolster.

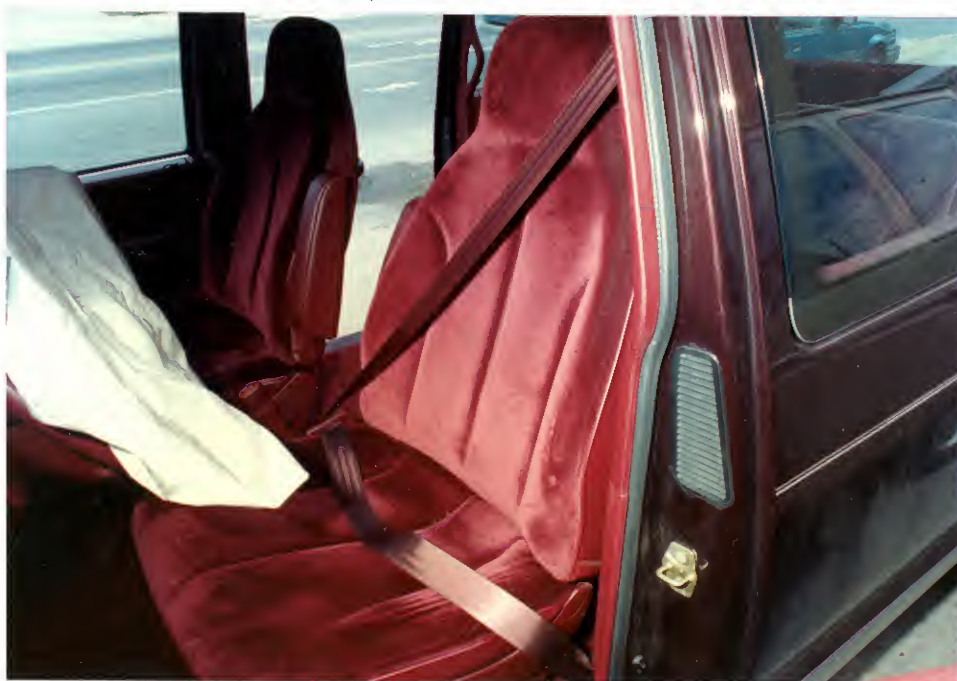
Driver's Active 3-Point Belt System.

The driver of the 1991 Dodge Caravan was in a normal, upright seated position at impact with both hands bracing against the steering wheel at the 10 and 2 o'clock positions. Her seat was adjusted to a rearward position, 5.1cm (2") from the full rearward position and the seat back was set to a near vertical position. The vehicle was equipped with a standard non-tilting steering column. The driver was properly wearing the active 3-point lap and shoulder belt webbing. Belt usage was supported by driver and police statements, driver injury patterns, the lack of interior occupant contact points, and by routine usage wear marks that were visible on the latchplate. There was no evidence of driver loading on the active belt system.

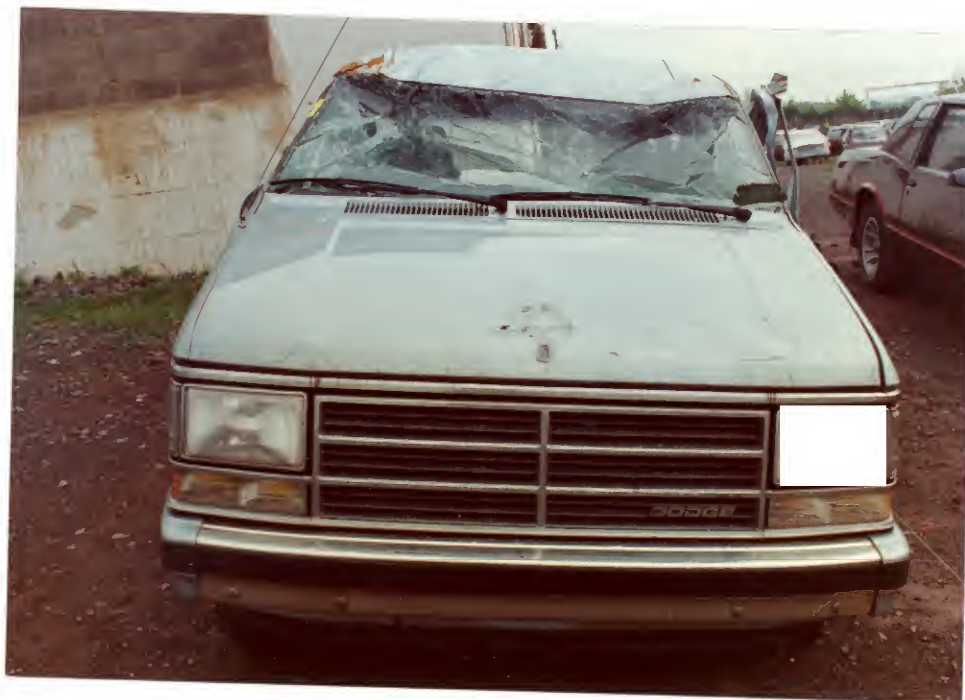
Frontal View Of The 1988 Dodge Caravan.

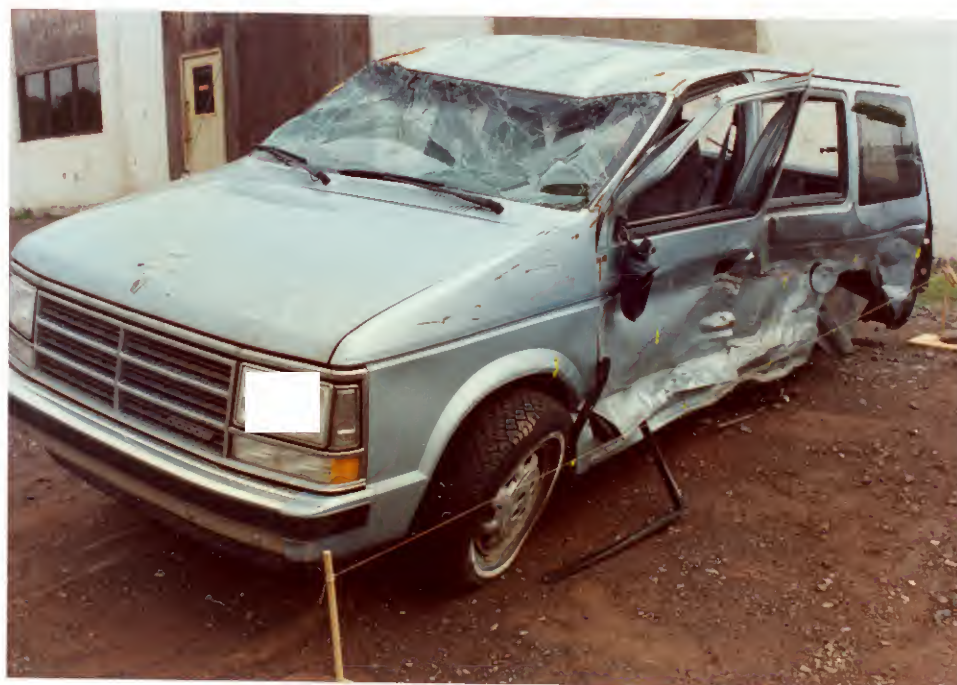
Left Front Three-Quarter View.

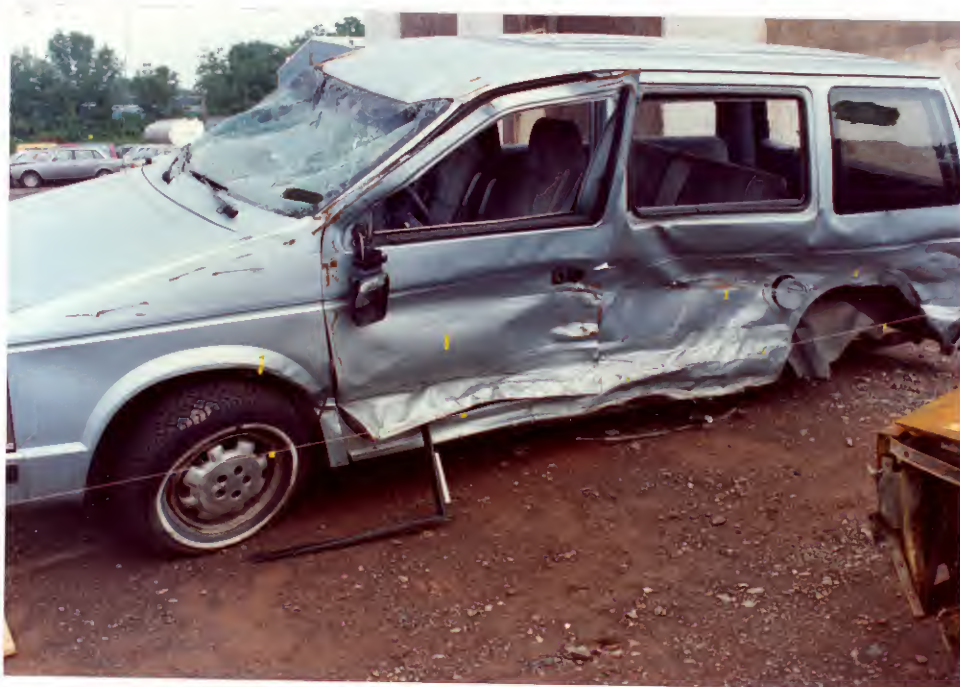
Initial Impact Damage To The Left Side Of The 1988 Caravan.

The 1988 Dodge Caravan sustained moderately severe left side damage that began on the left front wheel and extended down the entire length of the van. Maximum crush was 21.9 cm (8.625") located at the lower body crease 17.8 cm (7") rearward of the left B-pillar. The Field L was 330.5 cm (130.1") with the following crush values: $C_1=4.4$ cm (1.75"), $C_2=14.6$ cm (5.75"), $C_3=19.1$ cm (7.5"), $C_4=20.0$ cm (7.875"), $C_5=14.3$ cm (5.625"), $C_6=0$ cm (0"). The front bumper of the 1991 Caravan impacted the left rear tire and wheel of the '88 Caravan with sufficient force to fracture the left rear axle which resulted in complete separation of the wheel and brake assembly.

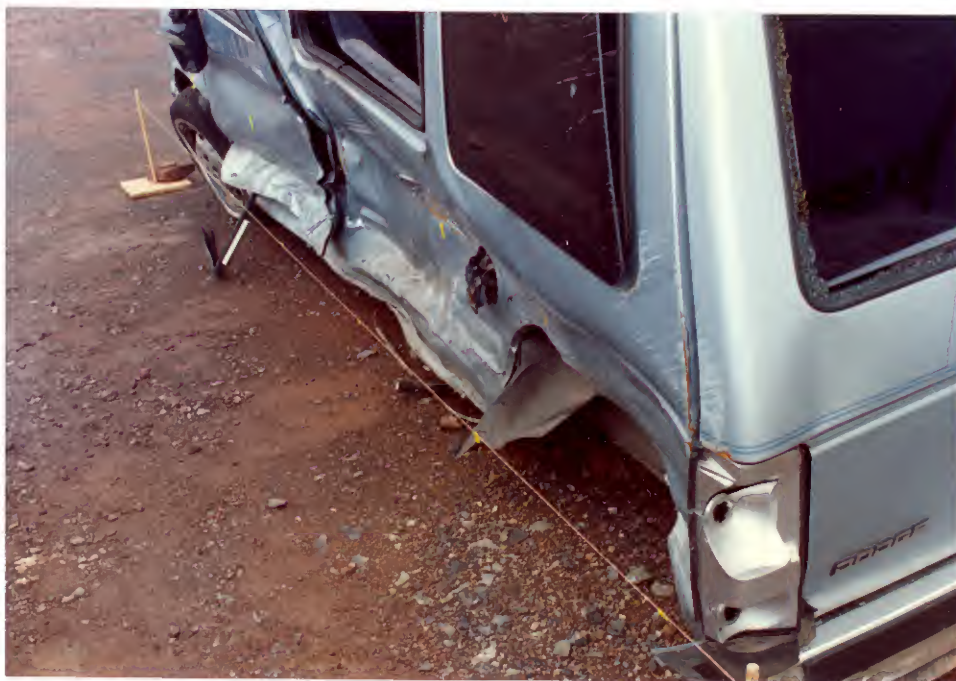
Longitudinal View Showing The Extent Of Crush.

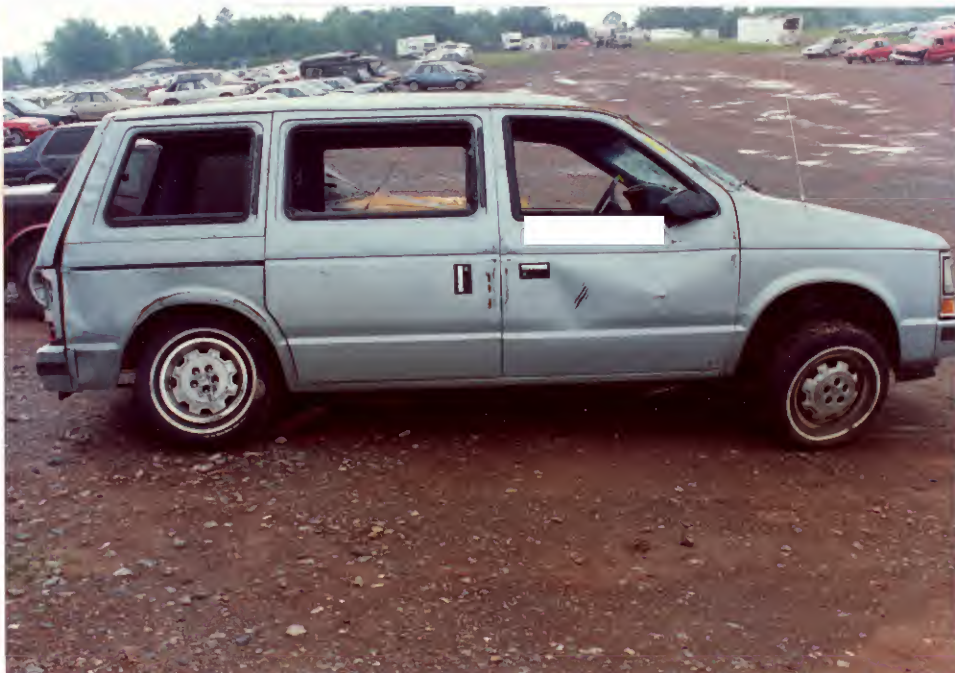
Right Side View.

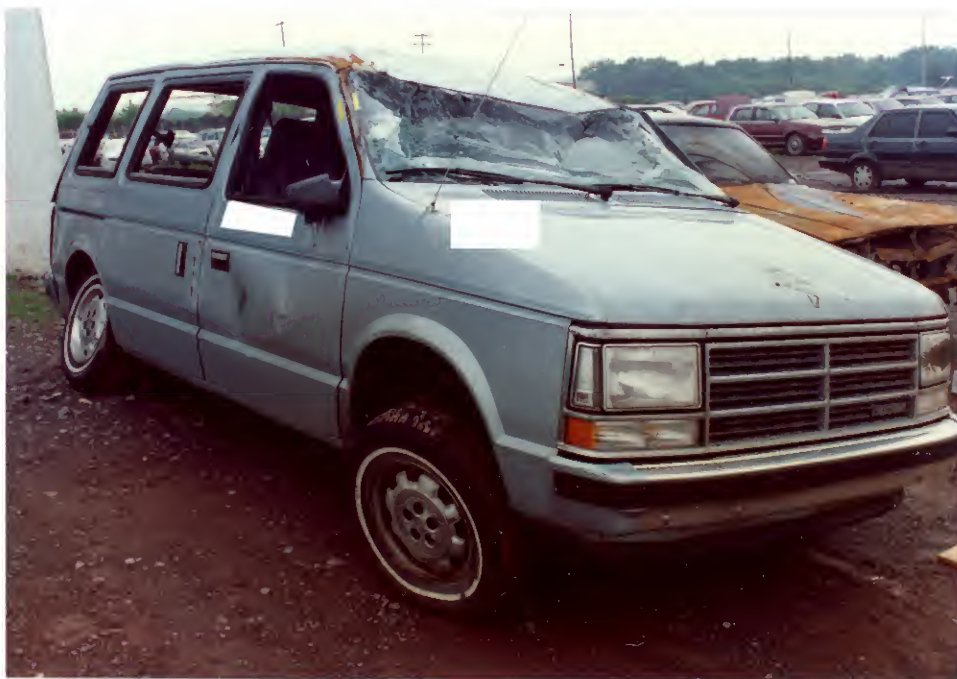
Right Front Three-Quarter View.

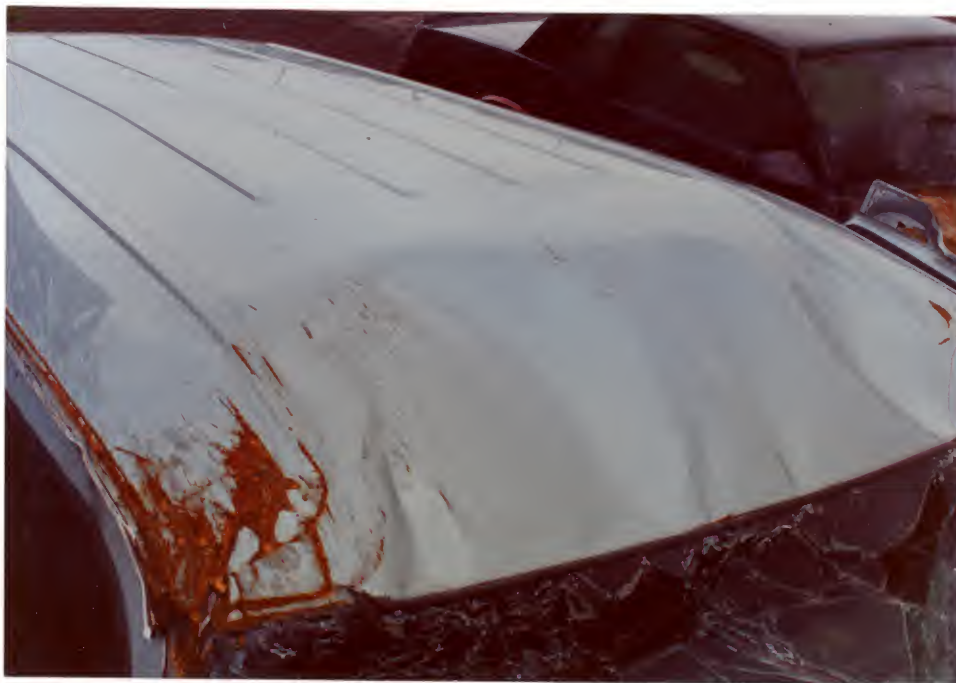
Rollover Damage To The Roof Area Of The 1988 Caravan.

overturned on the concrete road surface. The vehicle initiated a side-over-side rollover sequence leading with its right side. Direct contact damage (i.e., abrasions) began on the right front fender flare at the axle position and extended 358.1cm (141") to the rear corner. The direct contact damage extended vertically up the right A-pillar and down the full length of the side rail. The vehicle's contact with the ground deformed the right roof gutter downward which prevented the right doors from opening. As the vehicle continued onto its roof, the van was pitched with its front side down due to the front wheel drive forward weight distribution. The paint abrasions were distributed across the full width of the roof and extended 25.4cm (10") rearward of the right B-pillar. The remainder of the roof was not damaged. The hood sustained direct contact damage that extended 71.1cm (28") left of center and 40.0cm (18.5") right of the center-line. Maximum roof crush was 8.9cm (3.5") located at the windshield header directly above the steering column. Rollover damage also extended the full length of the left side of the vehicle. The left rear quarter window was opened during the rollover and was scratched, but not broken. All other side glass and the backlight were shattered during the rollover. The windshield was cracked due to deformation of the A-pillars and the windshield header. There was no bond separation or laminant tears in the windshield.

The interior of the 1988 Dodge Caravan sustained moderate damage from the left side impact and rollover sequences. The left side structure and the roof intruded into the passenger compartment. Maximum intrusion involved 8.9cm (3.5") of displacement of the windshield header and roof into the driver's position. The left roof side rail and upper left A-pillar were displaced 5.7cm (2.25") downward. The left door panel was displaced 6.4cm (2.5") laterally into the driver's seated area. The left rear occupant space sustained 7.6cm (3") of intrusion of the left B-pillar and side panel. The right front occupant's space was reduced in size by 5.1cm (2") of displacement of the windshield header area.

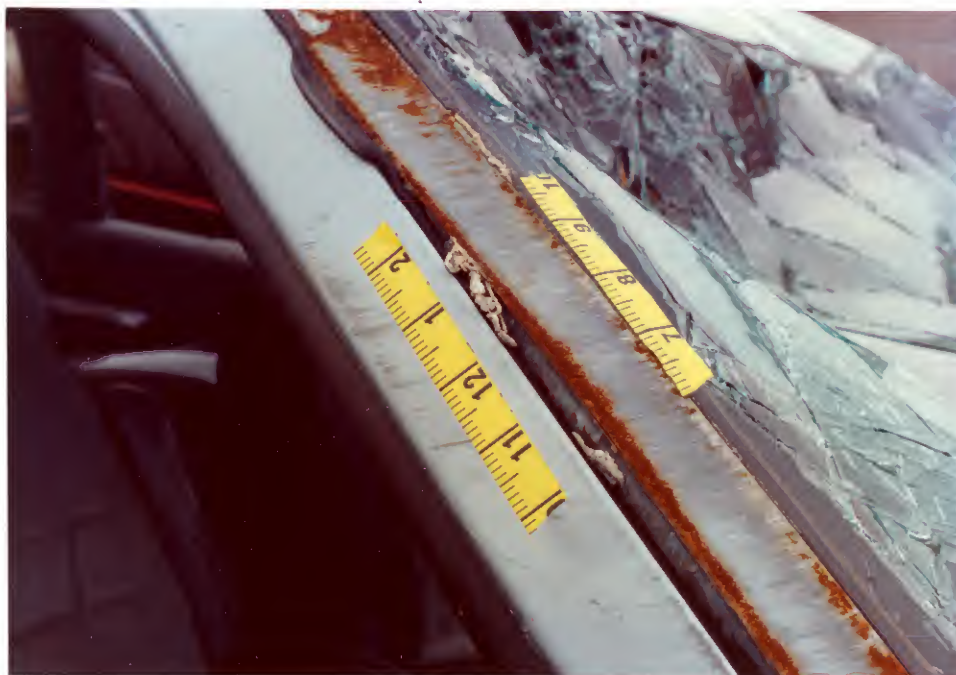
Sneaker Fragments In The Right A-Pillar/Door Window Frame.

During the rollover sequence, the right front occupant's left foot traveled through the right front door window opening and was crushed (AIS-3) between the concrete road surface and the right upper A-pillar. White rubbery material (probable sneaker) was found embedded in the pillar adjacent to the door window frame. The dorsal aspect of her foot was also heavily abraded (AIS-1). The passenger subsequently unfastened her belt system and crawled out of the left front door window. She was transported to a local hospital and admitted for treatment of her injuries (10 days). The driver was treated and released at the same hospital.

During the subsequent rollover event, the right front passenger's left foot was thrust outboard of the vehicle through the right door window opening. The side glass was shattered during the rollover sequence. Her foot was crushed between the right upper A-pillar/door window frame and the concrete road surface. Fragments of her sneaker were found embedded in the pillar/window frame juncture and in the windshield trim gasket. As a result of the contact sequence, she sustained a large abrasion of the dorsal aspect of the right foot and a crushing injury of the foot which involved multiple metatarsal fractures.
